Preserving Historic Structures at the Longview Show Horse Arena

*Becky Flege, P.E.
Bob D. Campbell & Co.
Structural Engineers*

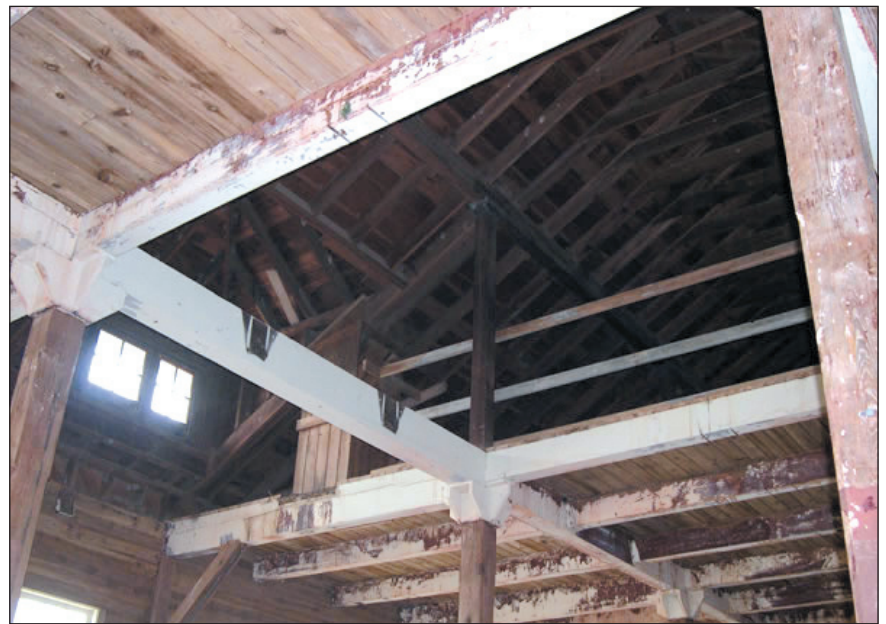
The original construction documents dated May 15, 1913 were drawn by architect Henry Hoit, who also designed the Kansas City Power and Light Building. The drawings included very detailed specifications of the cast-iron columns and bow trusses in the arena, which is now the gymnasium and cafeteria. When analyzed, the cast-iron structure met current de-

sign criteria. However, once demolition began, it was discovered that the base of several of the columns had corroded severely. Normally in this circumstance a structural engineer might recommend welding steel shapes to the existing column to reinforce it. However, because the framing is cast-iron instead of steel, an alternative fix was designed using a concrete wrap and bolted connections.
